# Bamboo Shade House

## Building a Growing Area for Summering Cattleyas

TEXT AND PHOTOGRAPHS BY TP PLIMPTON

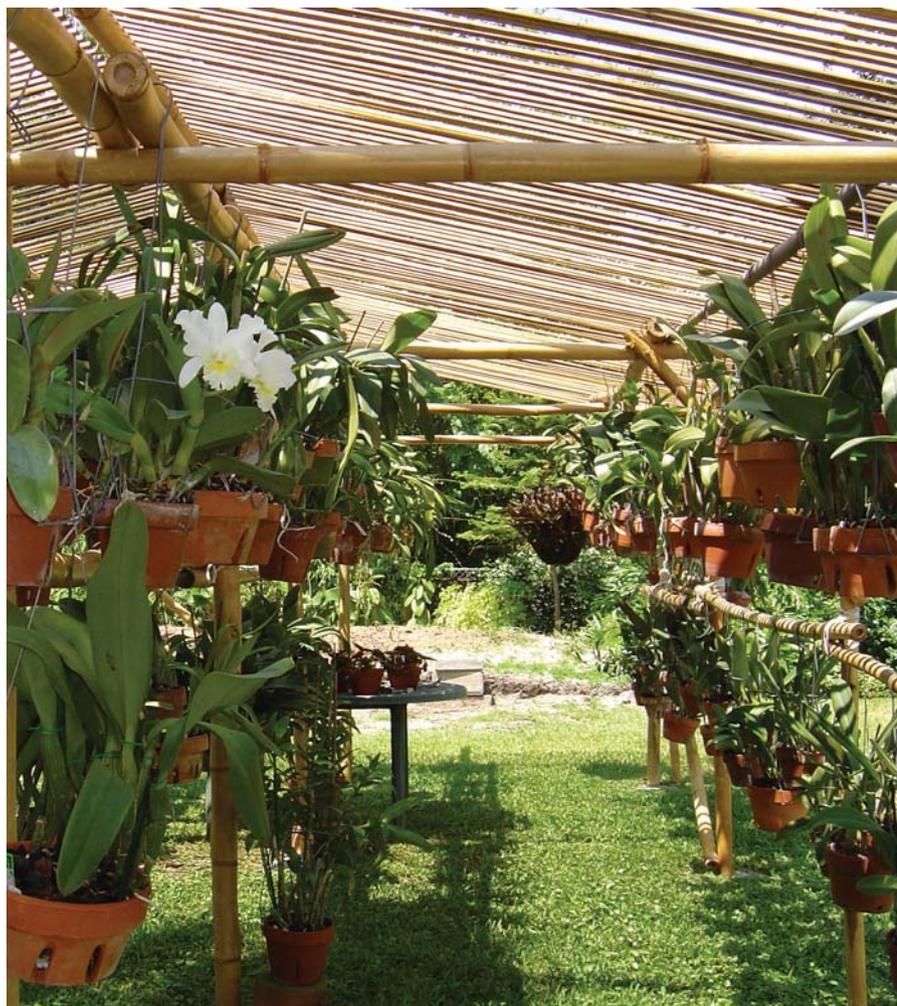
**ABOVE** During the summer, a cattleya collection is hung in this 30 × 12-foot (9 × 3.5-m) shade house constructed from bamboo. An assortment of oncidiums and vandas, as well as begonias, are also housed in this airy pavilion.

We designed the shade house to be 30 feet (9 m) long and 12 feet (3.5 m) wide. In the tradition of a pole barn, we spaced the bamboo supports at 7½ feet

(2.2 m), arranged in three rows 6 feet (1.8 m) apart. The side support poles are 7 feet (2 m) high and the center poles 8½ feet (2.5 m) high. Each pole is supported on a concrete footing into which had been cast a 1-inch (2.5-cm) PVC pipe extending 18 inches (45 cm) up from grade. Each pole, with nodes drilled to receive the extended pipe, was slipped over the pipe and pinned in place.

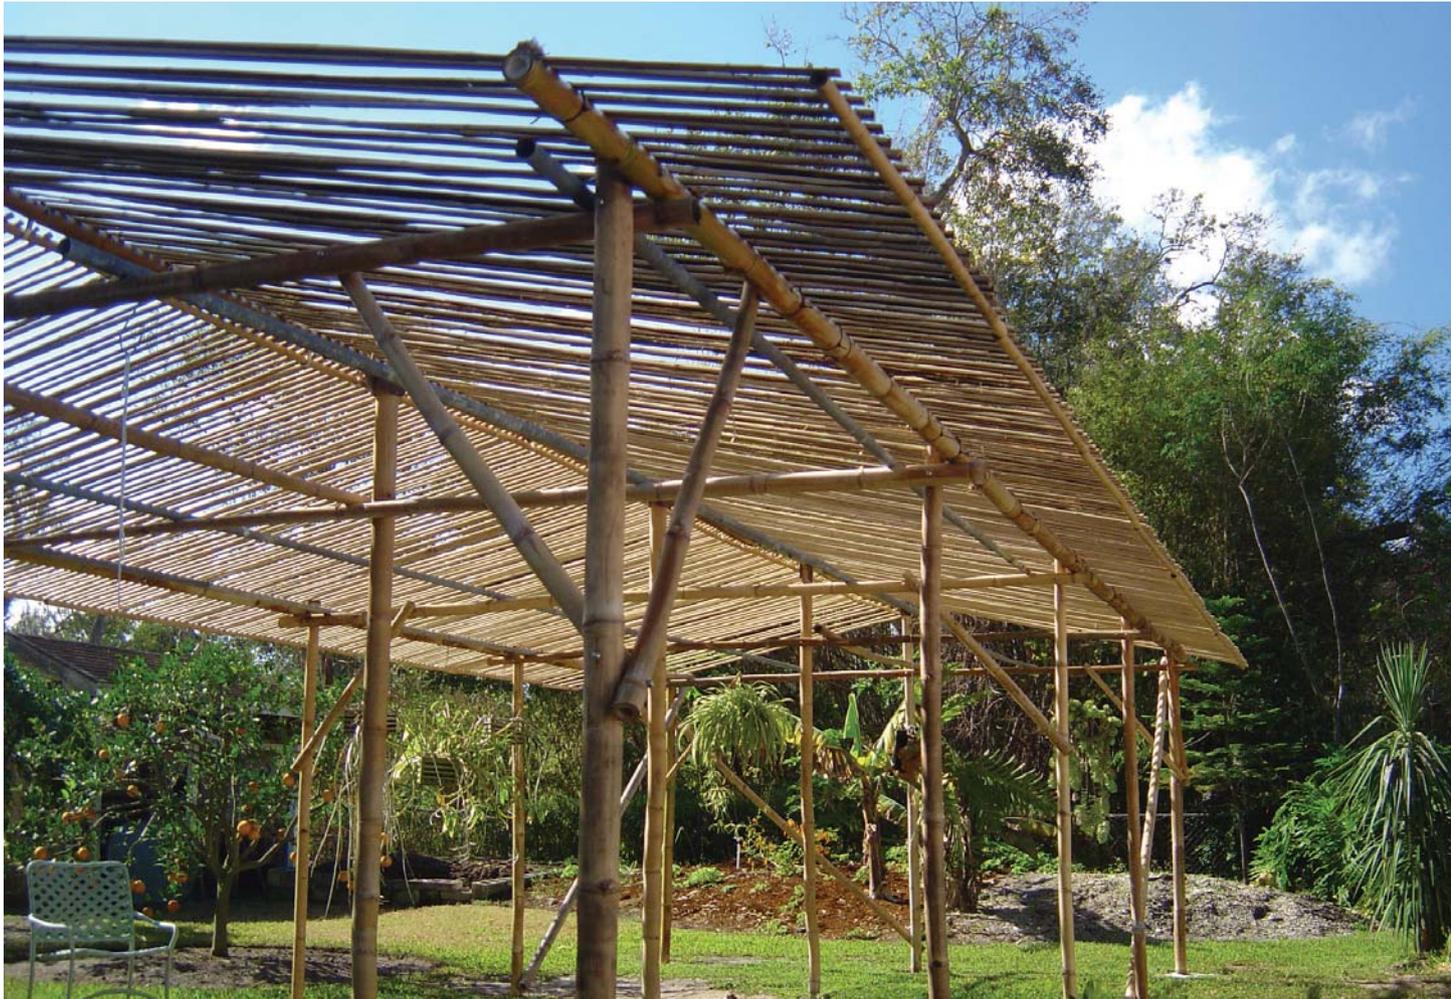
**OPPOSITE** Having removed a large oak, the Plimptons built a shade house from bamboo already growing on their property. Drawing on their experience as landscape architects, they constructed the shade house in the fashion of a pole barn to create an environment suited to the needs of their growing collection.

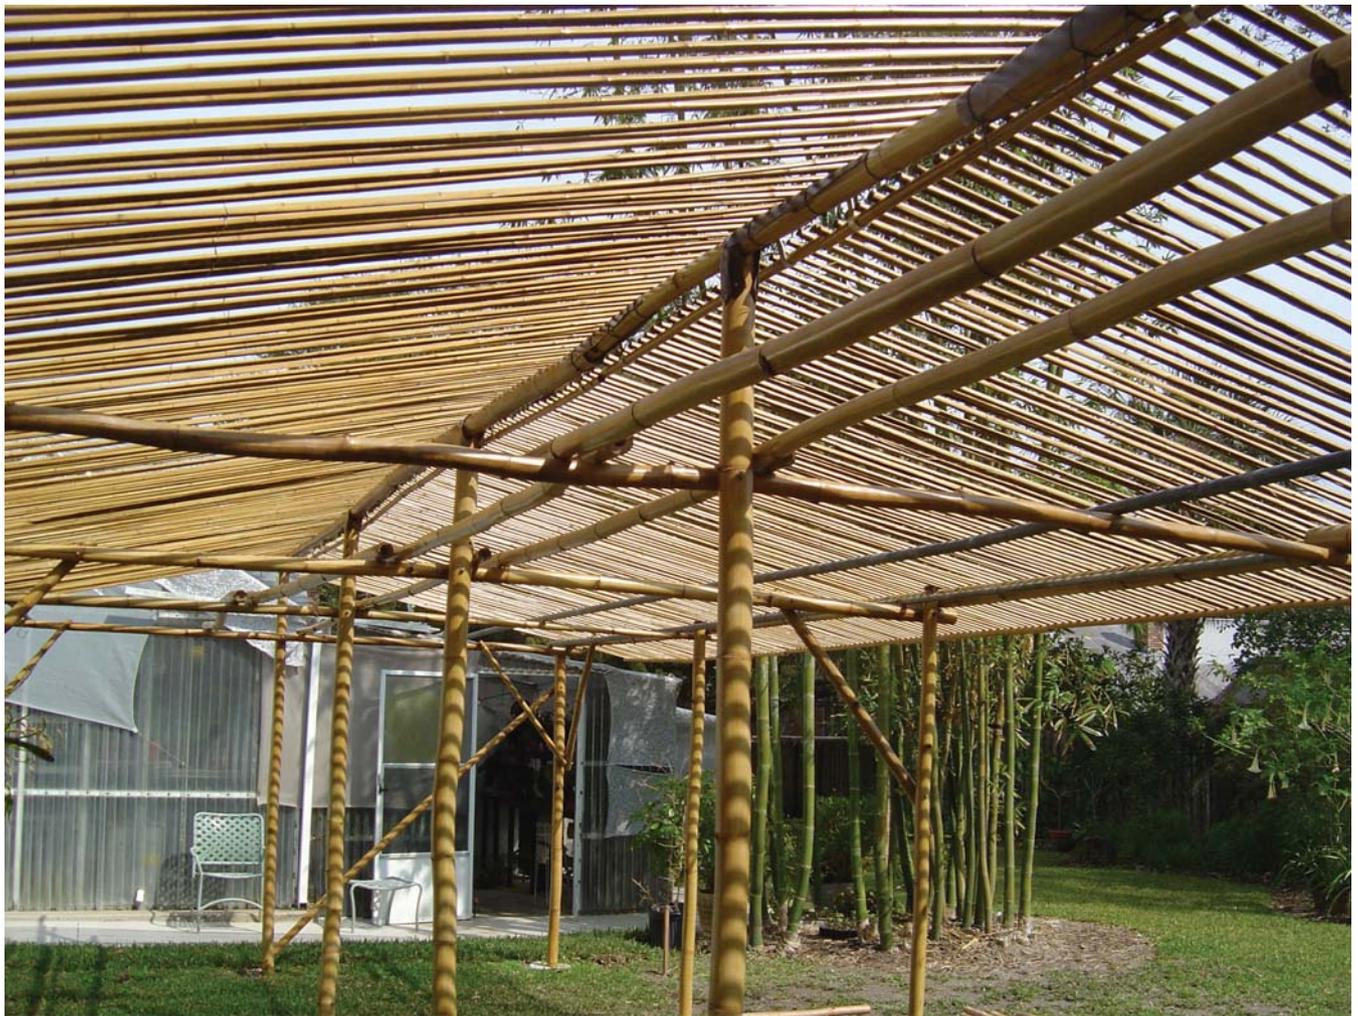
OPPOSITE The new shade house is adjacent to a Lexan greenhouse where the cattleyas are kept during the winter. The center ridge pole of the bamboo structure, measuring 34 feet (10 m) long, is made up of several pieces of bamboo spliced together.

**HOW TO** Construction began October 26, 2004, with the pouring of the footings and the setting of the poles. The two top plates, each a 32-foot (9.7-m) length of bamboo spanning the sides, were pinned to the side support poles with  $\frac{3}{16}$  inch (.18 cm) threaded rods with self-locking nuts. The center ridge pole, a 34-foot (10-m) length consisting of several pieces spliced together, was strapped down on top of the center support poles with straps designed to protect the upper end of each pole from the weather. The cross beams from side to side were bolted to the side posts underneath the top plates with  $\frac{3}{16}$ -inch (.18-cm) threaded rods.

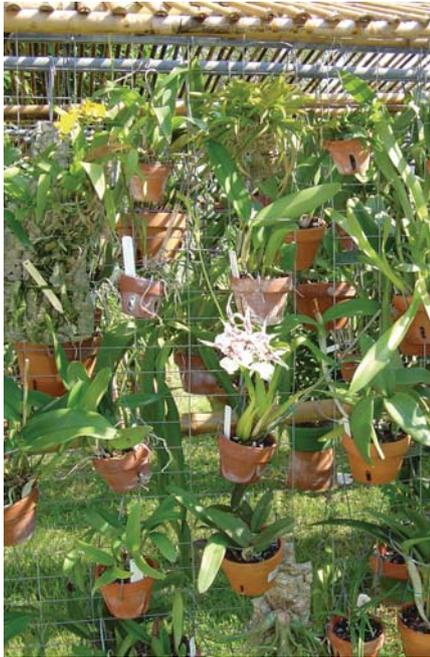
ABOVE LEFT A piece of wire mesh hung vertically increases growing space for potted orchids as well as a few mounted specimens. The wire allows for plenty of air circulation among the plants, and makes it easy to water.

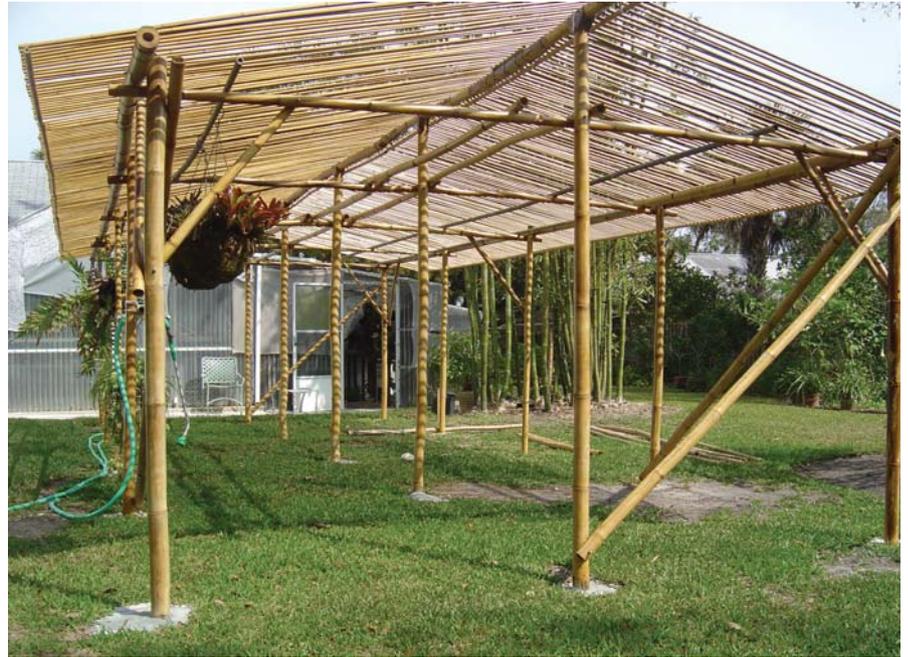
ABOVE Each pole is supported on a concrete footing into which had been based a 1-inch (2.5-cm) PVC pipe extending 18 inches (45 cm) up from grade. The lawn beneath the shade house is mowed regularly.
